# **REPORT OF ROAD INJURY SURVEILLANCE PROJECT OF THE ROAD INJURY RESEARCH AND PREVENTION CENTRE OF JPMC, KARACHI**

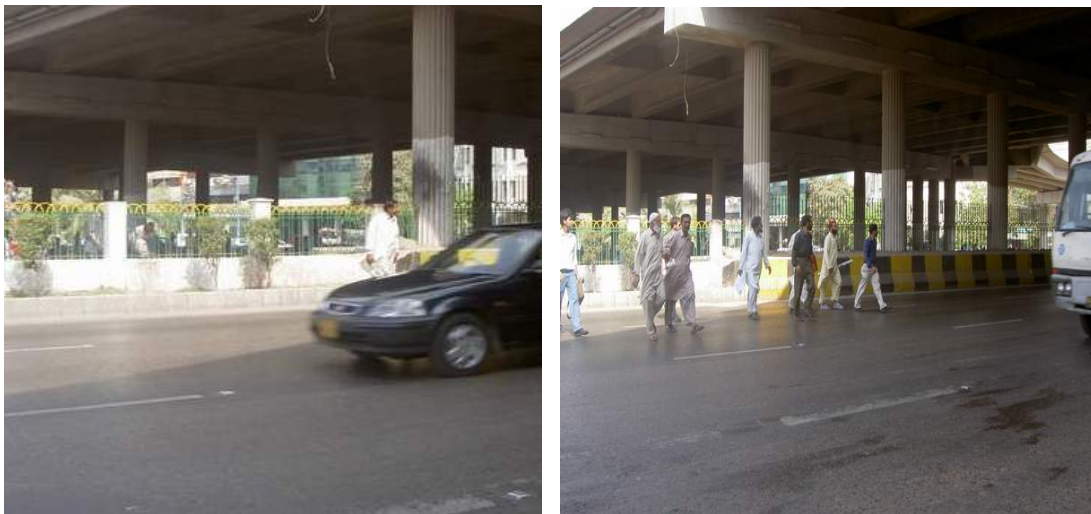
There are 2 pedestrian bridges provided, each at entry and exit of the flyover, but these haven't been utilized by the people due to the insignificant placement of bridge and lack of bus stop in the vicinity.

1. It is recommended that warning signs be placed for pedestrians crossing the road especially on the median to make them aware of the risk involved. Signs should also be placed telling the people to cross the road using the pedestrian bridges.
2. Presently the space below the Baloch Colony Flyover is acting as a de facto bus stop mainly due to large amount of shade available. Steps should be taken to end this practice and the proper bus stops built near the pedestrian bridges should be utilized for this purpose.

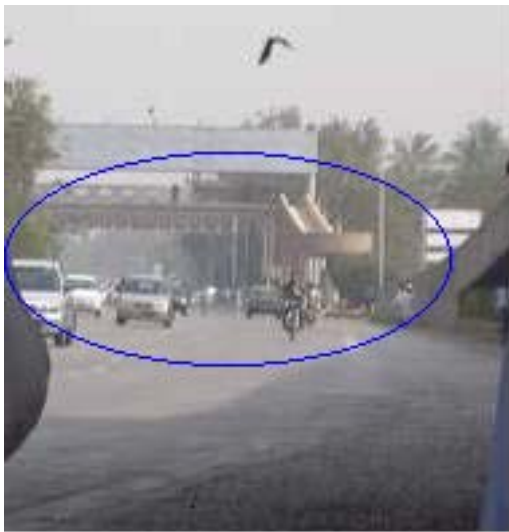
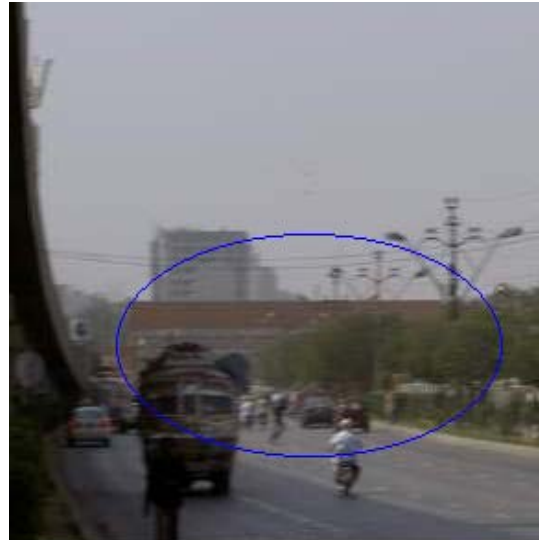
Usually the flow of pedestrian is under the fly over. A pedestrian facility provided at this junction is 1056 ft (0.2 miles) from the bus stop. Even if pedestrian wanted to cross the highway using side walks (3.5 ft) provided on bridge, he had to cross at least 4 roads including a median and intersection which comprise about 0.4 miles across. This situation instinctively wastes time.

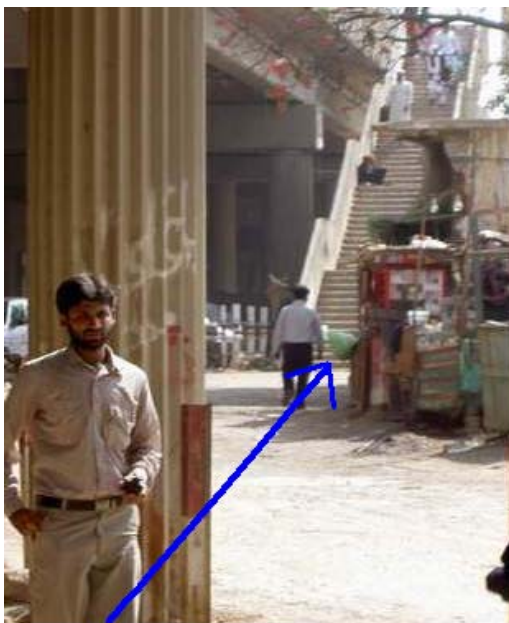
picture taken from bus stop under bridge which is 0.2 miles away

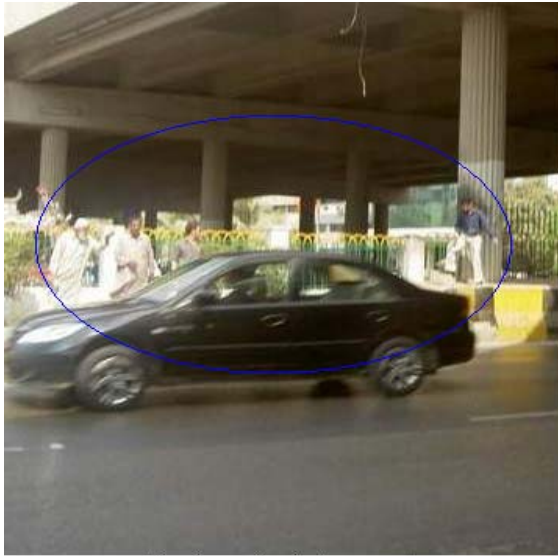
Thus people preferred using high speed road over the bridge. Secondly, the fencing is not providing their basic purpose. People skip over the fencing to cross the road.

people jumping over fencing to cross road

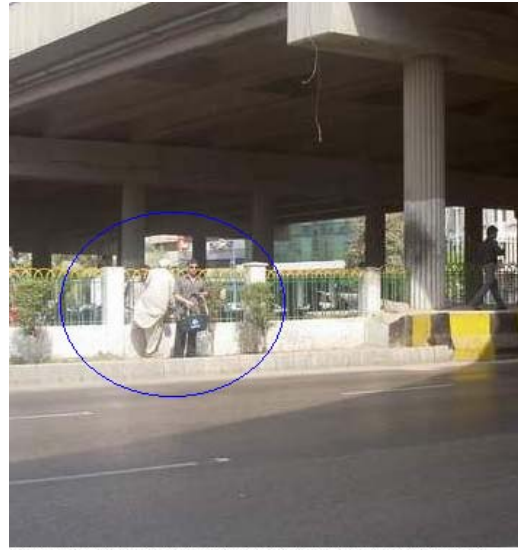
the man is going through the fence which people cut through for their convenience

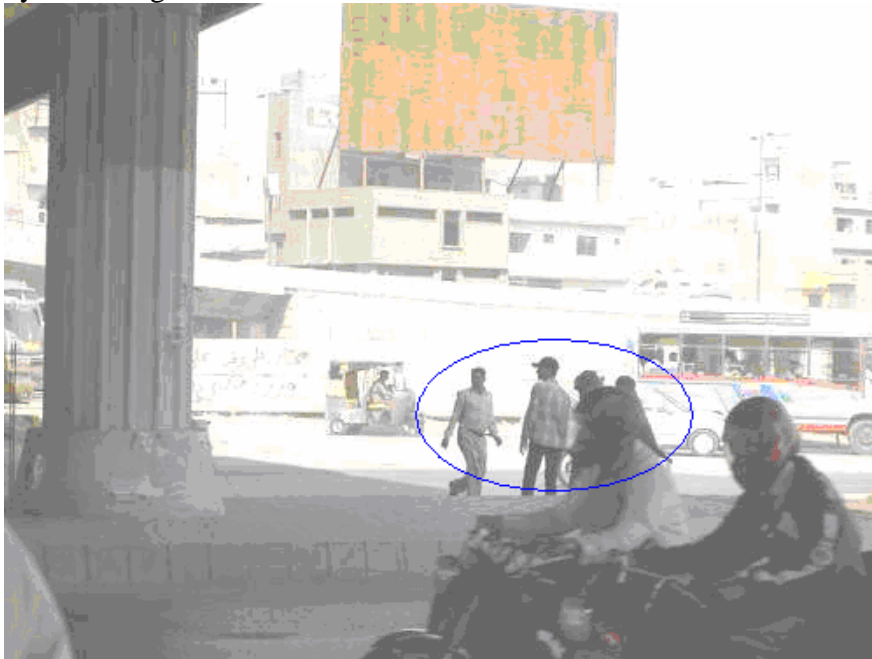
The FTC-Sindhi Muslim Housing Society portion of Shahra-e-Faisal has become dangerous for pedestrians due to heavy and high speed traffic making it difficult for people to cross the road. The construction of two flyovers - at the FTC / Gora Qabrستان and the second at Nursery - and the removal of signals along this stretch had compounded the problem. Most of the accidents reported from this location are of pedestrian and there the severity rate is high.

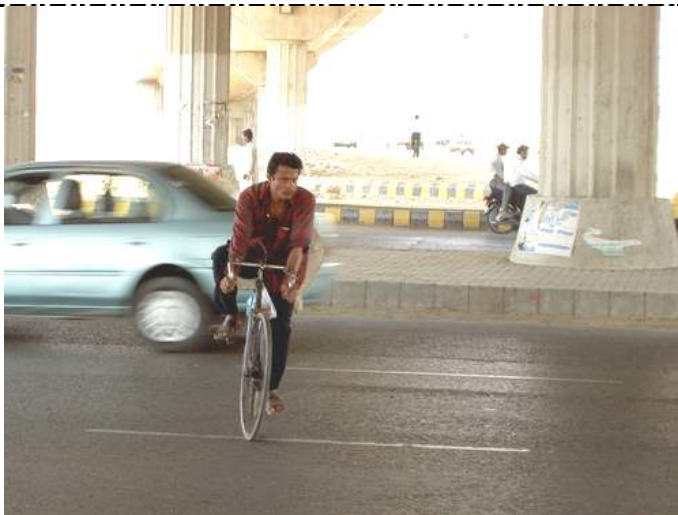
We observe that the vehicles on this road are moving with a very high speed and smooth flow, to this flow the sudden entry of a pedestrian crossing a road is posing great problem. One of the reasons of pedestrian crossing on this road is that buses stop in front of FTC on the opposite side of the road, so those people have to cross the road anyway instead of utilizing the pedestrian bridge located near Sindhi Muslim turning. Due to the bus stop designated at the end of FTC flyover, a conflicting point is generated between the public transport trying to approach bus bay provided at left and the vehicles descending from bridge and approaching to high speed lane. It is very risky to cross when it is a peak hour. It is easy for a young person to go on the other side of the road as compared to older people and women. Women take more time to cross the road while men are more confident. The other reason is that there is no fencing provided to stop the people from taking risk of their lives. An overhead bridge is provided near Aisha Bawani College but unfortunately it is not utilized to its maximum because it is not located at the place where pedestrian flow is present. Pedestrian movement is generated from Bizerta and lines area and they want to cross the road at the convenient spot and are not willing to travel a long distance to approach pedestrian bridge and then use pedestrian bridge to cross the road.

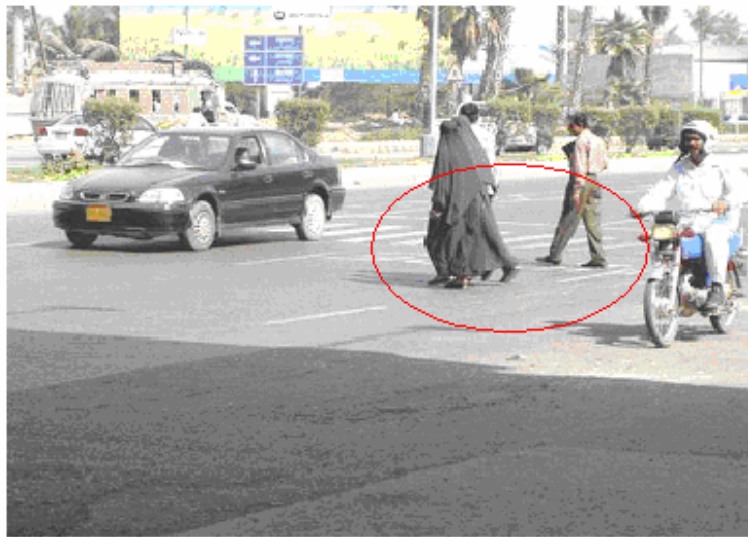
One of the geometrical discrepancies existing at that point was the presence of a zebra crossing below the flyover. The zebra crossing existed before the flyover was constructed & only signalized at-grade intersection was present. The construction of the fly over made this portion of the flyover a free-flow zone with almost full access control. This resulted in the increase of the vehicular traffic speed. Presence of zebra crossing allows the pedestrians to cross this heavy flow, high speed stream; endangering their lives & distracting the drivers, resulting in extreme rear-end & side swipe collisions of the vehicles.

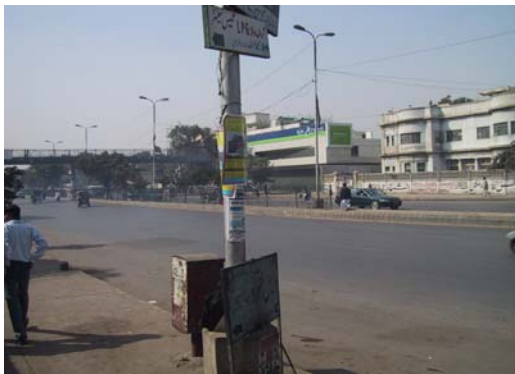
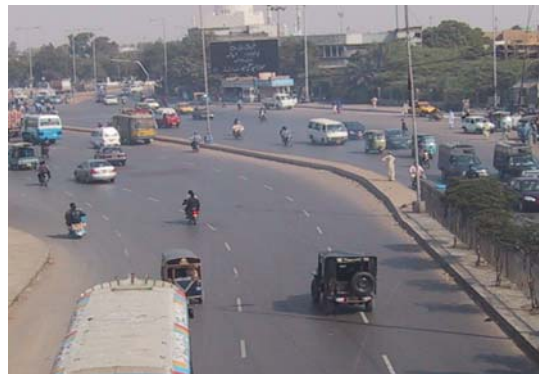
1. Pedestrians are not using the designated bus stop; they stand before bus stop on the road where they are hit by vehicles coming from signalized intersection.
2. For road crossing on M.A. Jinnah road pedestrians are not using pedestrian bridge. This is due to the fact that initially there was a roundabout, which was then converted into signalized intersection but fencing present at the median was not extended to the intersection. Fencing on the median is not present at the place where the most pedestrian are crossing the road. This fact is clearly visible in the figure given below.

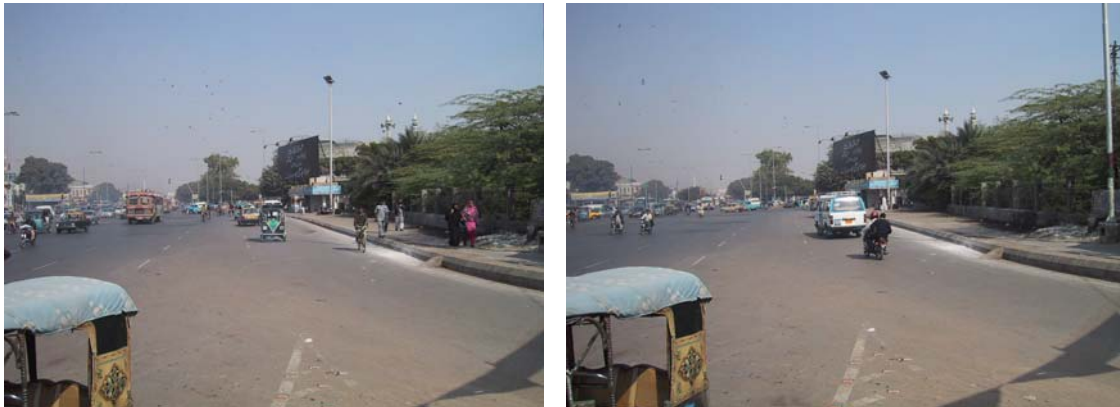
Many vehicular accidents have also been reported on Numaish Intersection. On survey of this intersection it was known to us that vehicles coming from Lines Area to M.A. Jinnah road and Shakra-e-Quaideen are following wrong way to approach Numaish Intersection. Due to driving on wrong way these vehicles are always at a risk of head-on collision. Figure given below clearly shows this fact.

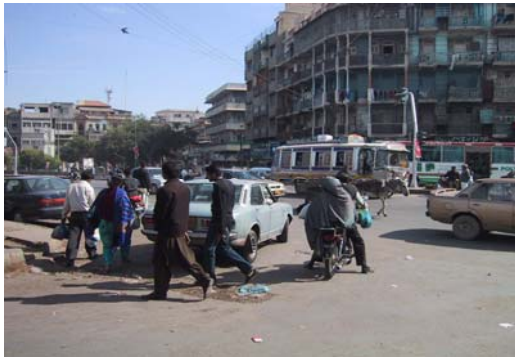
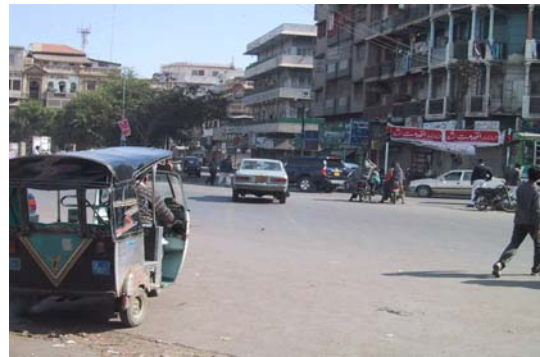
Jama cloth intersection is located on M.A. Jinnah road near Radio Pakistan station. On this intersection, M.A. Jinnah road is intersecting with Baba-e-Urdu road and the road that is coming from Shahra-e-Liaquat (also known as “frame wali gali”). After this intersection M.A. Jinnah road is one way. Just after this intersection a street (also known as phool wali gali) is connecting with M.A. Jinnah from Ranchor line. The movement of vehicles from phool wali gali to Baba-e-Urdu road is generating conflict points with vehicles coming from M.A. Jinnah road and vehicles coming from Shahra-e-Liaquat as shown in figures given below.

When this intersection was designed, no right of way was provided for the left turn of vehicles coming from Phool wali gali. Later on right of way was provided for left turn of vehicles coming from Phool wali gali and signal was installed without any change in geometry of intersection. Due to this reason it has become a black spot and many cases of accident have been reported from this intersection.

For the reduction in number of accidents and severity of accidents, following measures are recommended

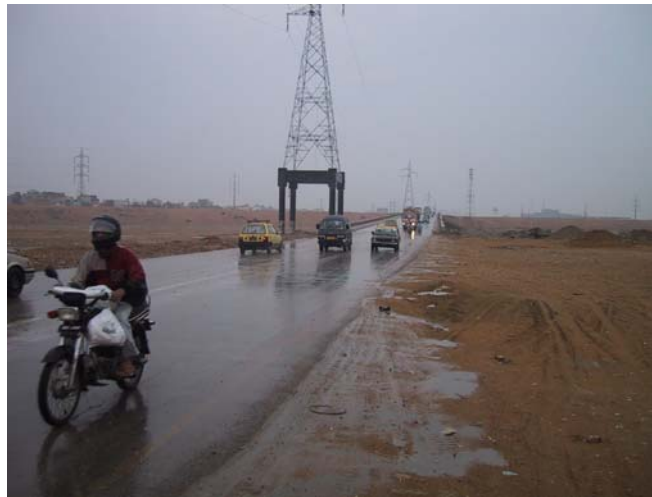
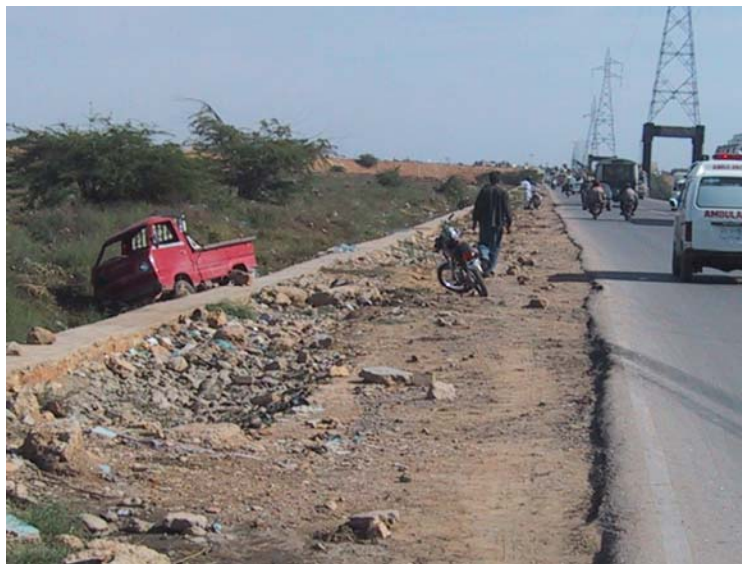
There are no street lights on the either sides of the road which is one of the causes of accidents on this road. In the night the road is very dark and risky toward accidents. In last two months most of the accidents were observed due to darkness on the road.

3. Provision of high intensity sodium lights.
4. Provision of mandatory Traffic Signs.
5. Repair of pot holes.
6. Removal of illegal sand loading truck stand.
7. Provision of Asphalt Bituminous Shoulder.

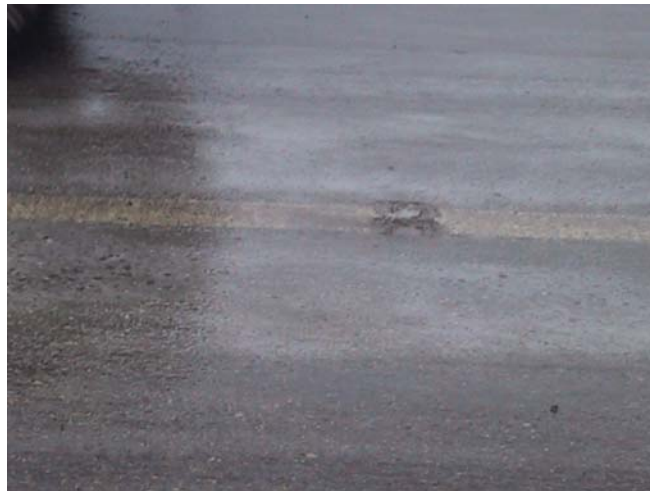
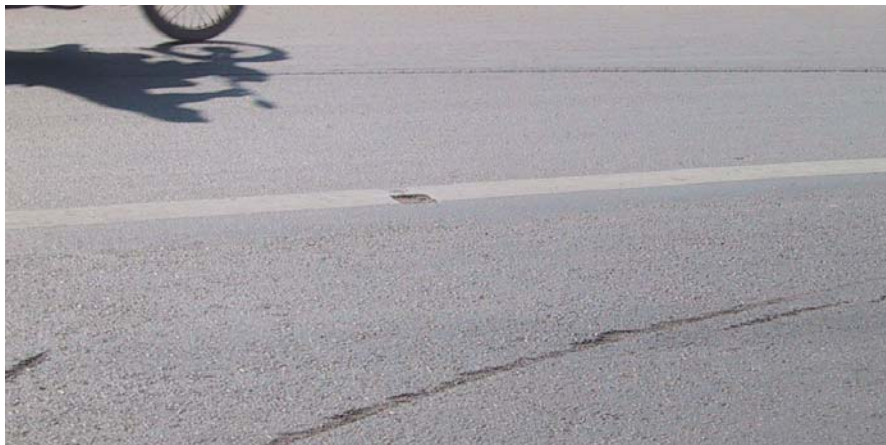
On the critical section of the road traversable median is installed due to the small width of the road. The marking of median has become very much lighter and is not obvious even in the day light. Reflectors are also not present on the median as they were installed but have been stolen. Due to diminished median marking and absence of reflectors the median is not clear and most of the vehicles are observed to overtake the other vehicles on the median due to this reason. Figures given below clearly indicate this fact.

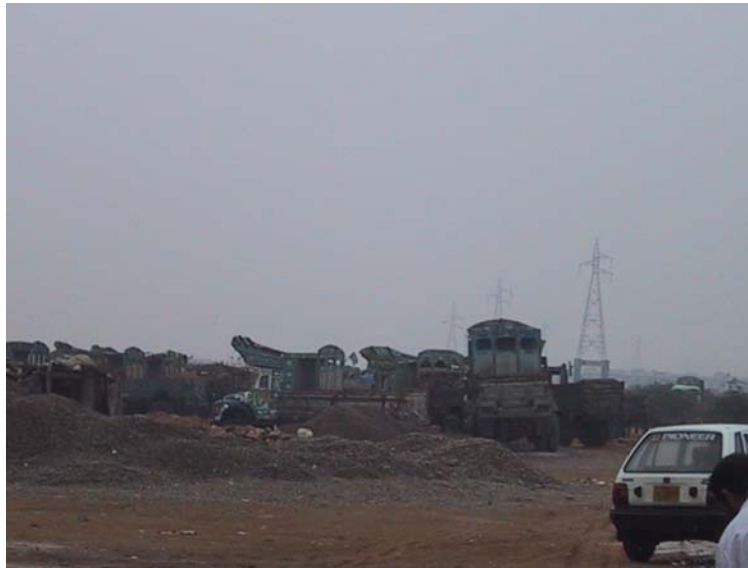
On the side of the trucks are loaded with sand and aggregate and then it is supplied to different parts of the city. The problem created by these trucks is this that they come suddenly on the road due to which risk of collision is always present at this road. The drivers of trucks are usually involved in rough driving which is the cause accident.

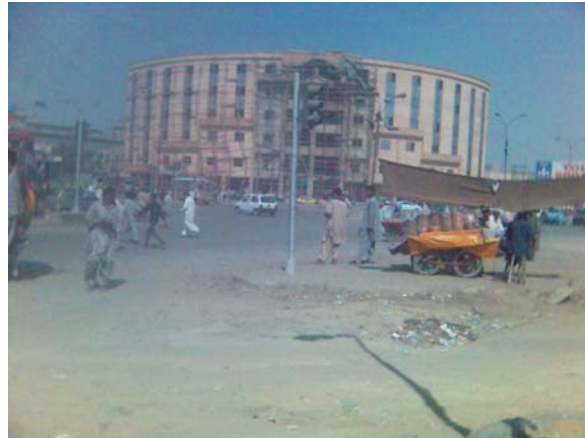
Picture-1, showing poor condition of pavement

Quality of riding surface at the intersection and link roads is very poor. Due to ditches and pot holes in the riding surface, two wheeler vehicles are misbalanced. This problem becomes more critical in dark conditions. Picture given below clearly indicates this fact.

1. Quality of riding surface should be improved by repairing existing pavement.
2. Street lights should be repaired to improve driver's visibility during night.
3. Proper Island may be constructed at the centre of intersection and light signals may be installed in the central island.
4. Geometry of intersection and alignment may be reconsidered.
5. Construction of Bus bay, Allocation of Bus Stop and its enforcement on all four legs of the Intersection.
6. Pedestrian Bridge should be constructed keeping in view the flow of Pedestrian.

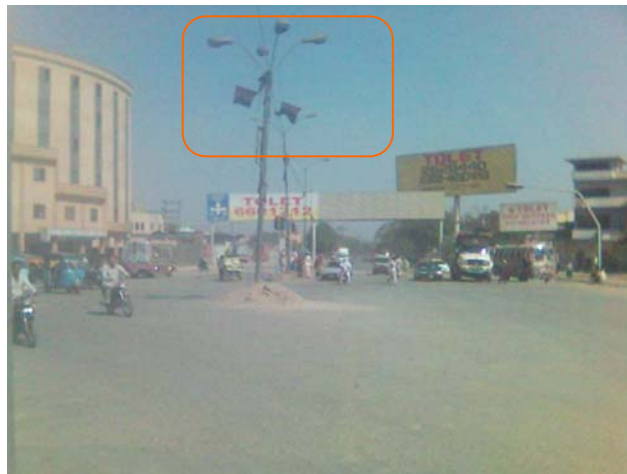
Picture-2, street light in centre of intersection

Street lights present in centre of intersection and on the link roads are not in working conditions. Due to this reason, it becomes a blind intersection in the night times and become a cause of accident on this intersection. Picture-2 shows the street light present in the centre of intersection, which is not in working condition.

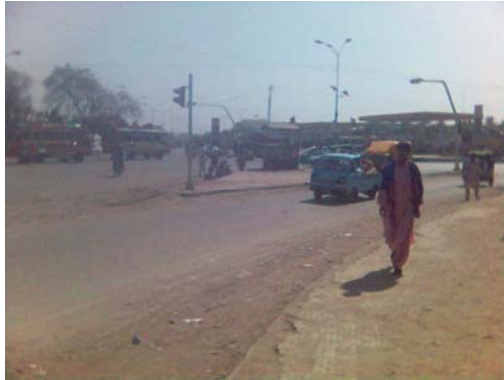
Picture-3, island for left turn

Ghani intersection is a four leg intersection with provision of exclusive left turn. No light signals are provided for the vehicles turning left on all four legs. It has been observed that most of the left turn signals are not being followed. So the intersection islands should be designed to provide safe exit to the left turning vehicles.

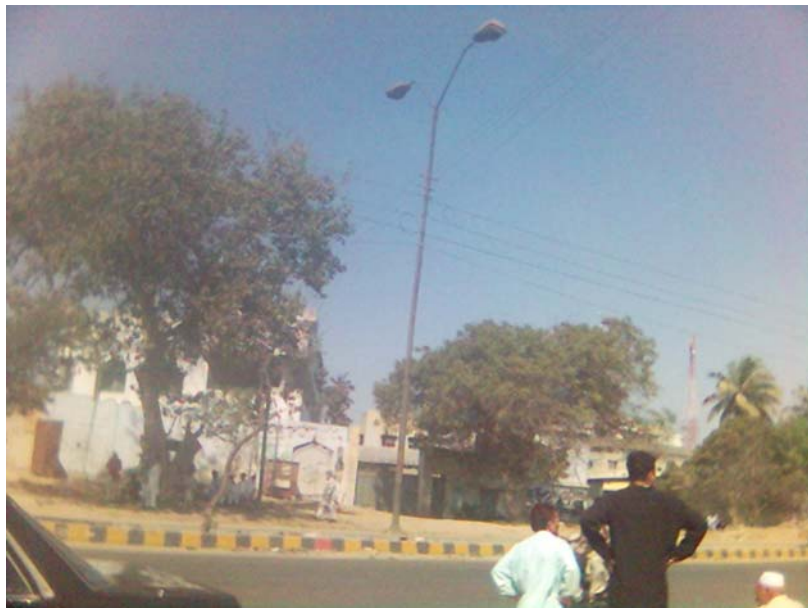
Haroonabad is a residential colony situated at Site Avenue near RC Cola Company. Due to this residential colony present at Site Avenue road, there is a huge pedestrian flow across the road. From the knowledge of local area people, it was known to us that pedestrians are involved in accidents very frequently on this road. These accidents are very severe because of the movement of heavy vehicles and high speed of vehicles. Another problem on this location is that the street lights present are not in operating condition or either they are not being operated.

1. Pedestrian bridge should be constructed at Haroonabad to provide safe road crossing to the people living there.
2. Fencing should be erected along with pedestrian bridge to deter pedestrian to cross the road and optimum utilization
3. Bus stop should also be provided along with pedestrian bridge to attract the flow of pedestrian through pedestrian bridge.
4. Street Lights on this road should be repaired and their working should be ensured.

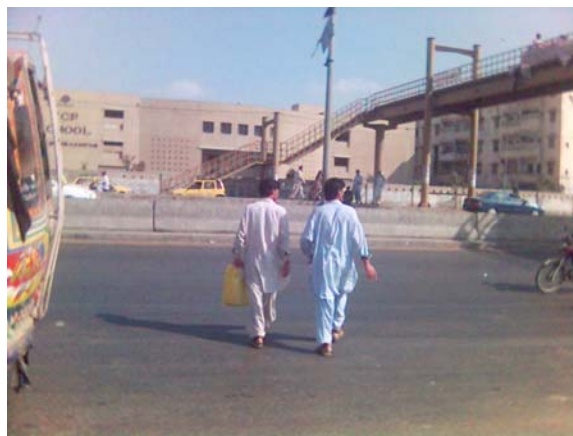
Fencing should be provided on median near pedestrian bridge to deter the pedestrian to cross the road. But in this case instead of providing fencing on median, New Jersey barriers of height 2'6" are provided which can be traversed. Some time pedestrian are misbalanced while crossing the barrier and it may be very dangerous for them if they are hit by vehicle. New Jersey Barriers are not sufficient to deter the pedestrian to crossing the road, fencing should also be provided along with barrier. Picture-1, given below clearly indicates this fact that people are not using pedestrian bridge but crossing the road under the bridge because they are not deterred to cross the road by barrier.

To reduce the number of pedestrian accidents, following improvements may be implemented.

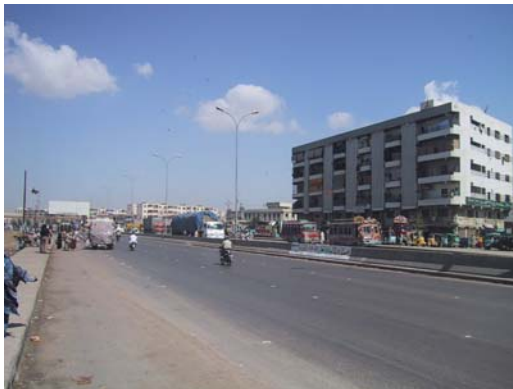
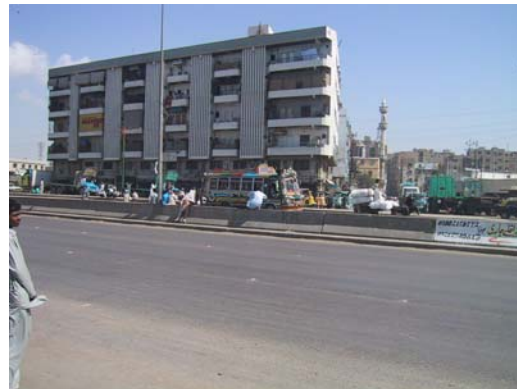
Pedestrian flow Near Wazir Mansion

There is a huge flow of pedestrian near Wazir Mansion (people Sports Complex) and near Crown Cinema but no facility is provided there for pedestrian to cross the road. A 2'6" high New Jersey Barrier is constructed in the median which has to be crossed by the pedestrian to approach opposite side of the road. Crossing this 2'6" high barrier is not an easy task for children, aged people and women and it is becoming hazardous for them.

No designated bus stops are allocated and no bus bays are provided to the passenger buses for loading and unloading of passengers.

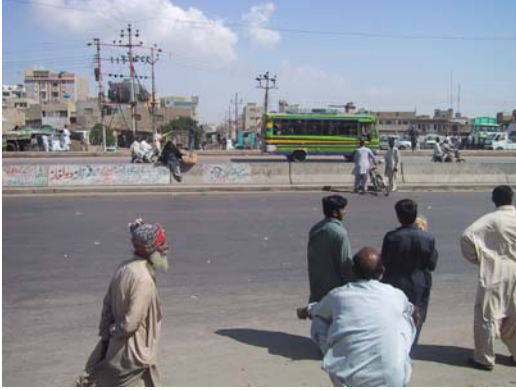
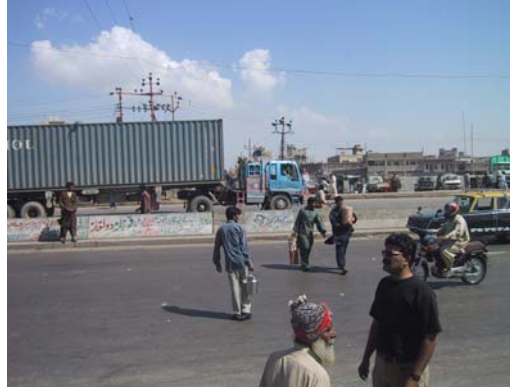
Flow of pedestrian near Crown Cinema

To reduce number of accidents on Mauripur road following improvements are recommended

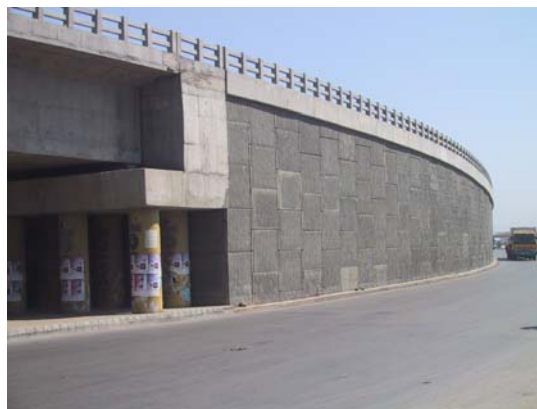
Due to the flyover constructed on Mauripur road to provide uninterrupted flow to the sea port traffic, the vision of drivers coming from Mauripur road to Hawks Bay Road is obstructed and they can not see the traffic coming from Shersshah to the Hawks Bay road, hence a severe collision may take place. Figure given below clearly indicates the above mentioned fact.

1. Warning signal (which repeatedly blinks on and off) may be installed near the intersection to resolve the problem of obstructed sight distance by giving an indication to the drivers that there is an intersection ahead.
2. Exclusive left turn may be provided for the stream of traffic coming to the Hawks Bay road from Mauripur Road to minimize risk of collision.
3. Geometry of Central Island may be altered to provide safety and flow, as its existing geometry is not designed properly.
4. Improper Island provided for segregation of traffic approaching intersection from Hawks Bay Road should be redesigned.
5. Street Lights should be installed at the intersection to improve driver's visibility during night times.
6. Rumble strips should be provided near the rail tracks so that the bikers slow their speed down and the problem of slippage does not occur.

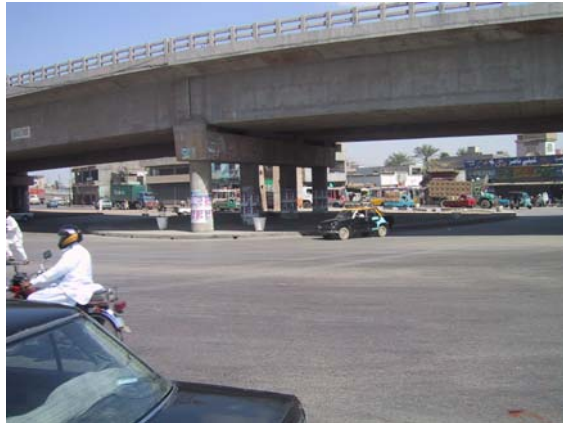
Geometry of central island of Gulbai Intersection is designed in ellipse shape. The design of round about would have been influenced by graves present there in Central Island. The existing shape of Central Island is creating problem when Lorries and other large vehicles take turn around it.

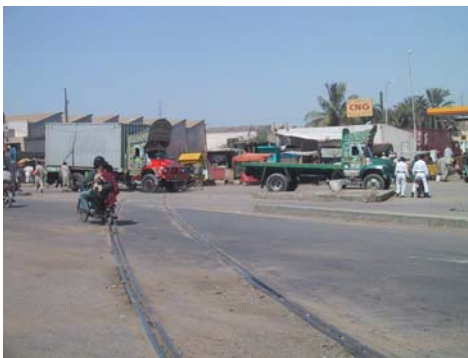
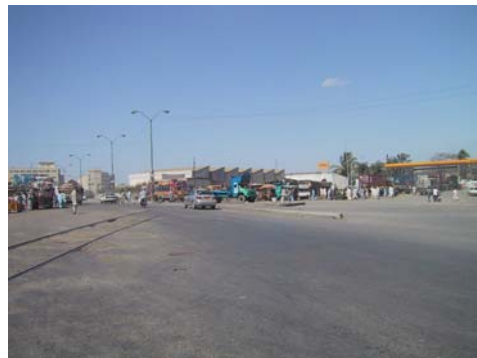
The islands of Gulbai Intersection are not properly designed. Island provided for segregation of traffic approaching intersection from Hawks Bay Road, is not properly aligned and designed hence becoming hazardous.

Another problem which is obvious from above picture is that bikes are slipped on the railway line due to slippage on steel rails.

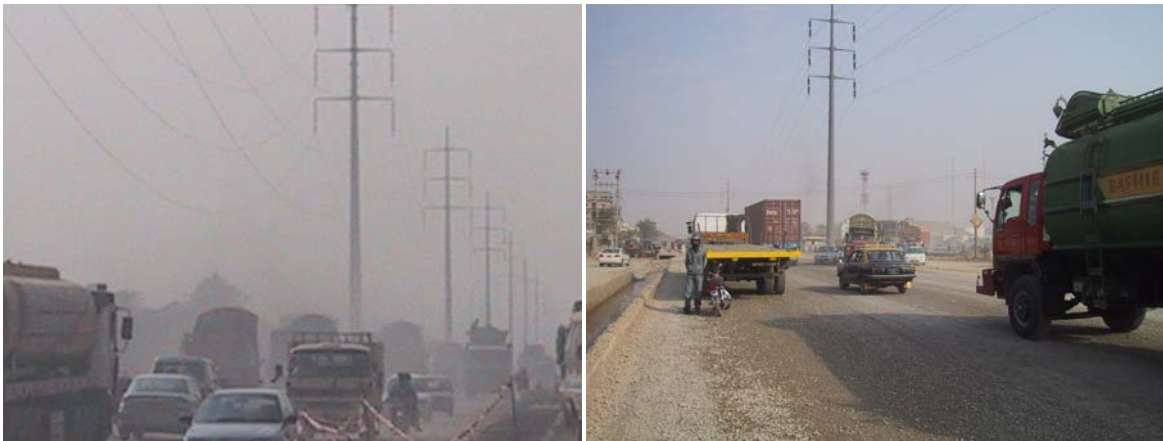
Pictures showing two way traffic operated on one road, near Chamra Chowrangi without any safety measure

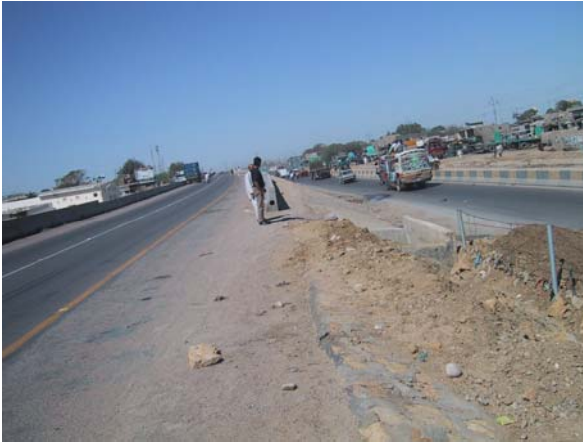
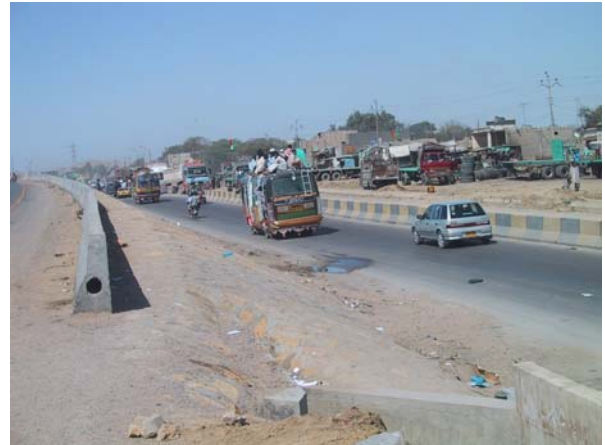
Motor bikes and light vehicles should not be allowed to operate on Northern Bypass. Most of the Bike Riders are resident of area around Northern Bypass. They look to cross from Northern Bypass to Hub River Road, which is becoming a hazardous practice. Motor bikes and Bicycles riders while descending from Northern Bypass to Hub River Road are unbalanced and hence may be involved in accidents.

Space from where rider descend form Northern Bypass to Hub River Road

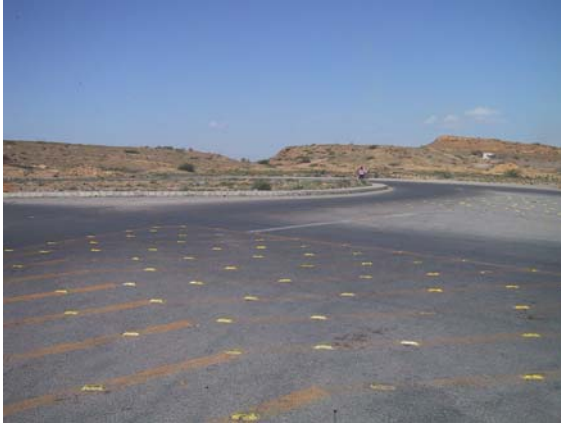
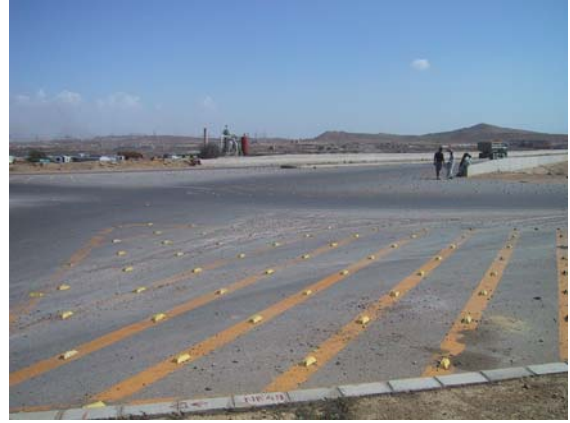
Vehicles coming from Hub River Road to Lucky Charhai are in high speed and there speed is not reduced when they approach Intersection. Three strips of rumble strips are provided which are not sufficient to reduce the speed of vehicles. Vehicles approaching intersection in high speed collide with vehicles approaching intersection from Northern Bypass and vehicles coming from Hub Chowki to Northern Bypass. Pavement markings and reflectors are provided at the intersection but they are not able to direct the traffic and reducing the speed of traffic while approaching Intersection.

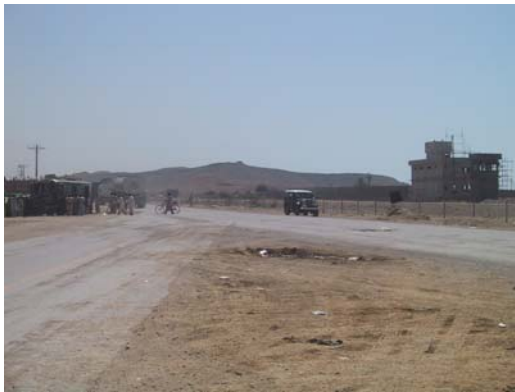
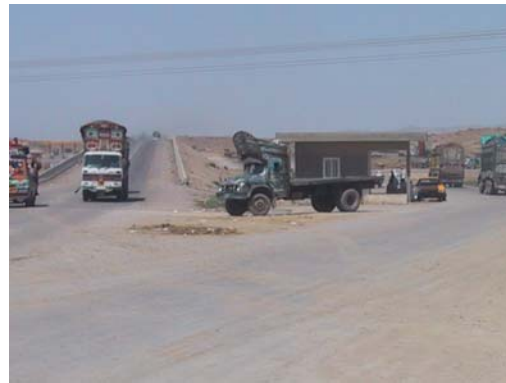
There is an uncontrolled intersection near Lucky Hotel after descending from Bridge of Lucky Charhai. This uncontrolled was the main cause of accident. At this intersection, right turning vehicles coming from Hub River Road to Northern Bypass create a conflict point with the vehicles coming from the Bridge of Lucky Charhai Intersection toward Lucky Hotel. Vehicles while descending from Bridge are in high speed and there is a high risk of serious head-on or right angle collision.

Figure showing uncontrolled intersection near Lucky Hotel

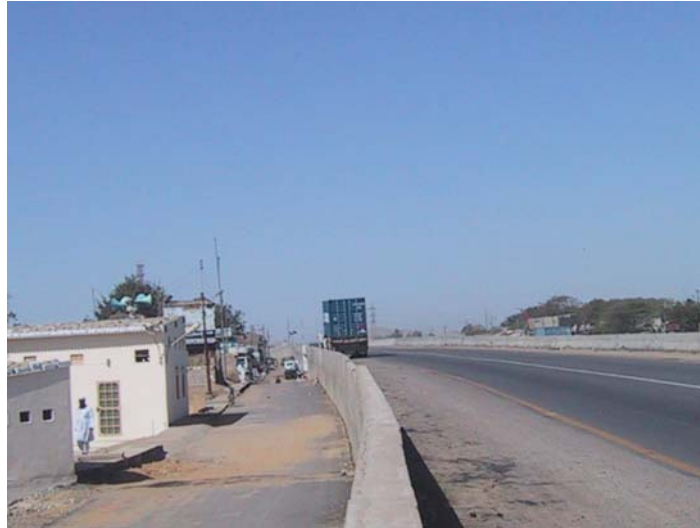
Pedestrian access is restricted on Northern Bypass. On one side of the Bypass fencing is erected while on the other side of the Bypass a high concrete wall is constructed to restrict the pedestrian to come on road. But people have made some spaces in fencing to access the road. Pedestrian movement across such a high speed highway is very much dangerous not only for pedestrian but also for the driver of vehicle because some times drivers while saving the pedestrian get involved in accidents.

In evening people residing near Bypass, use the walls along Northern Bypass for recreational purpose.

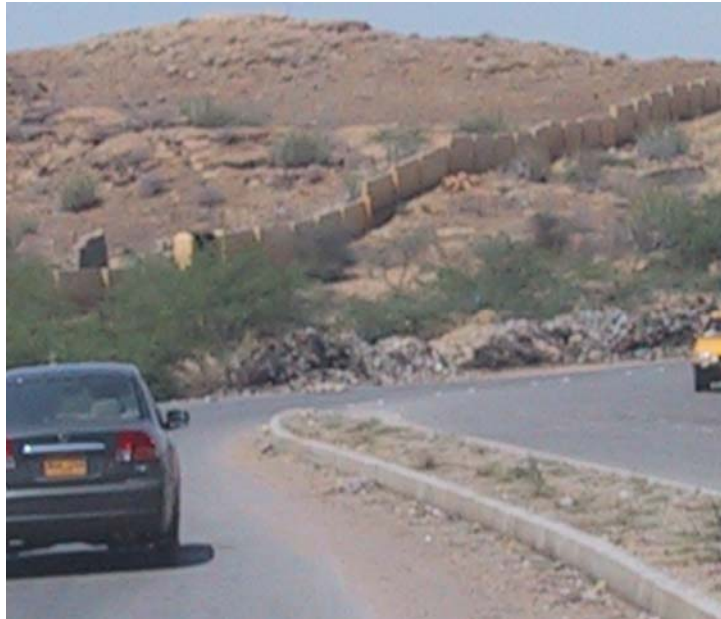
Vehicles responsible for dumping of solid waste of the city dump the waste along Northern Bypass and Hub River Road instead of disposing the waste in Land Fill Site Near Jam Chakro. This practice is illegal and creating environmental hazards. Also, after dumping the garbage these dumpers make a U-turn on the fast moving road, to go back to the city, hence creating a risk of an accident happening.

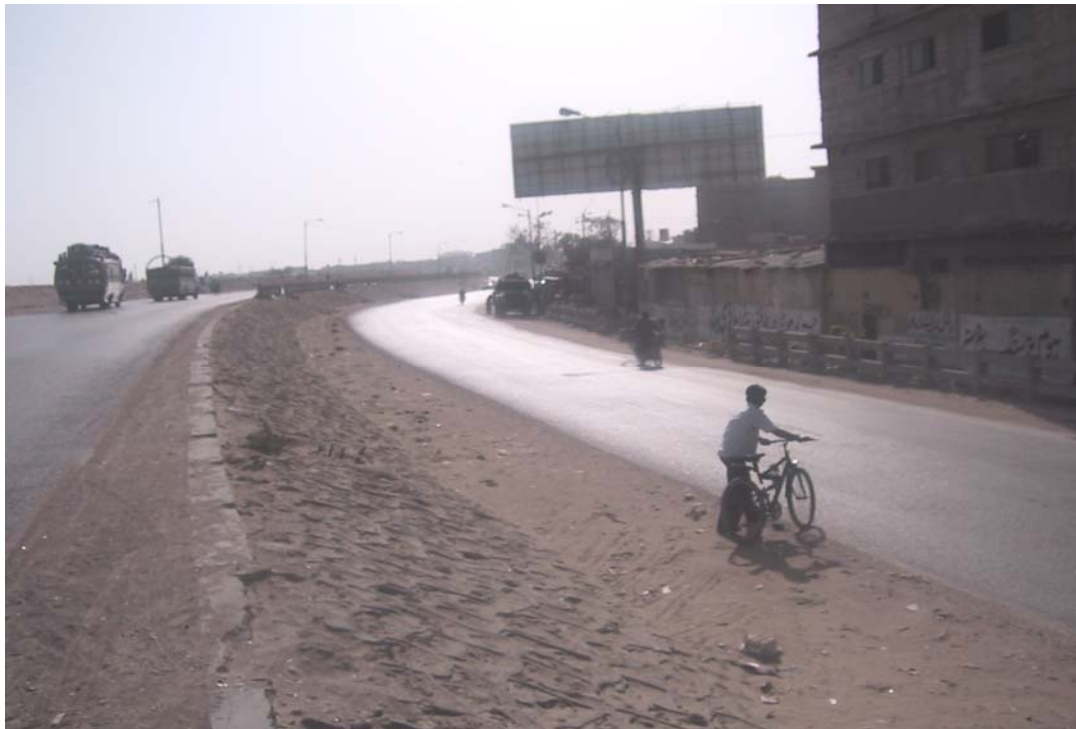
A concrete barrier is constructed in the middle of two grade separated roads to deter the pedestrians and bikes so that they would not be able to cross the road except at their designated spots and the cars do not come on to the wrong side. This barrier presently is in a dilapidated and rundown condition now and is completely absent at some sections. In absence of the barrier, motorcyclists, cyclists and pedestrians are crossing the road wherever they want giving rise to a dangerous situation

On the horizontal curves on Shaheed-e-Millat express way concrete barrier have been deteriorated from most of the places due to which high speed vehicles from upper road may fall down to lower road and may cause a chain reaction.

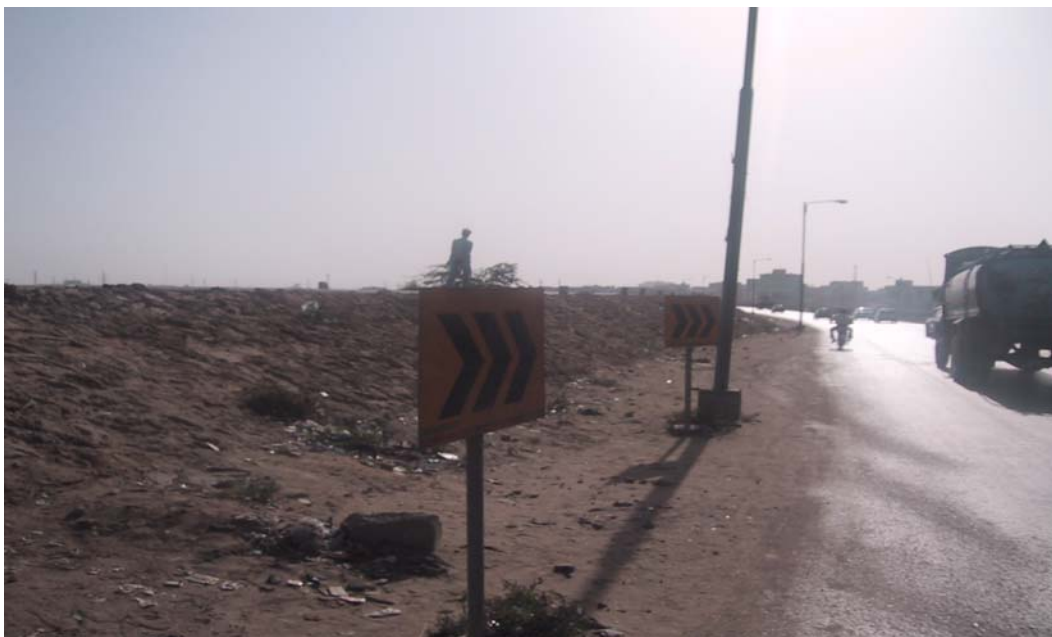
There are some warning signs on the curves which have been placed by Alamgir Welfare Trust but they are not placed at the appropriate position and not accurately directed therefore they are not serving their purpose.

Proper warning signs should be placed before horizontal curves on the road to warn the drivers that they need to be slow down their speed as horizontal curve is ahead.

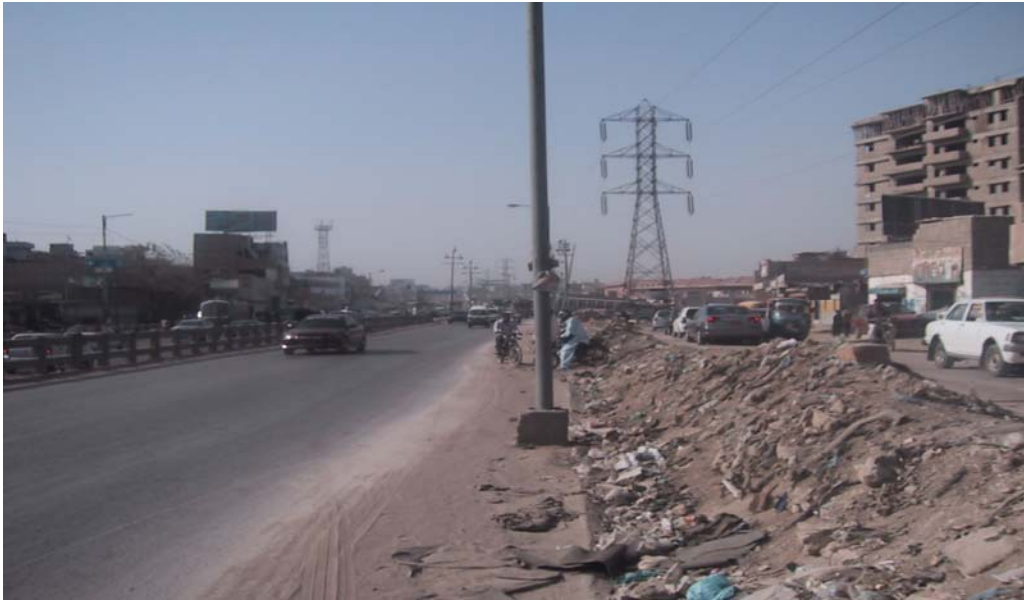
Wrong way movement is being practiced on Shaheed-e-Millat Expressway, by bikes and cycles, near the PAF School intersection. This has given rise to an unsafe situation which needs to be addressed.

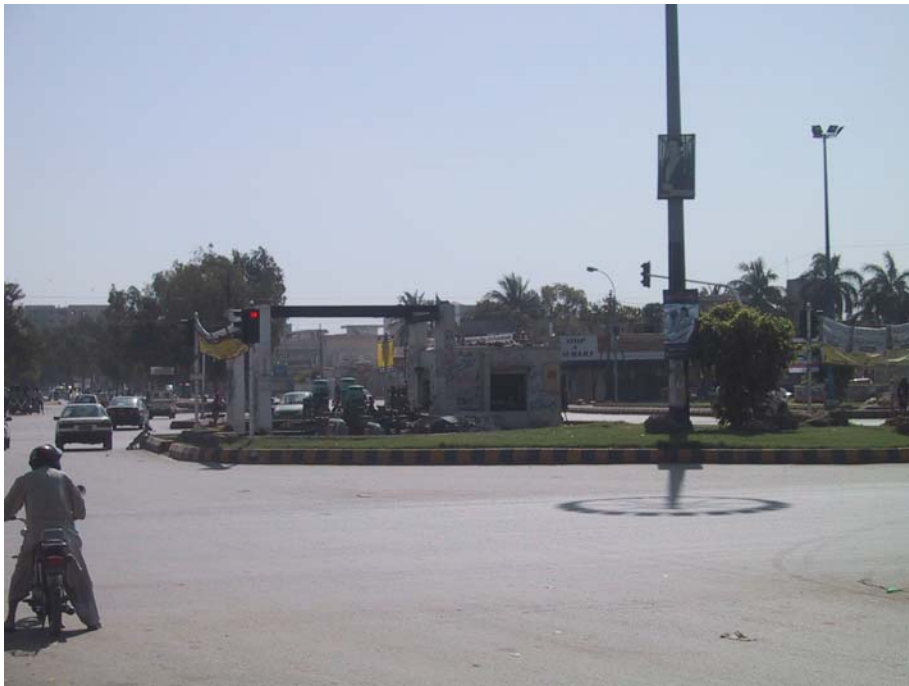
Also, banners are tied at this intersection which causes further obstruction.

Another important issue is that when the signal is non-functional due to load shedding and is being manually operated by a traffic constable. Due to site obstruction it is difficult to get a view of the constable from all four directions which leads to traffic jams.

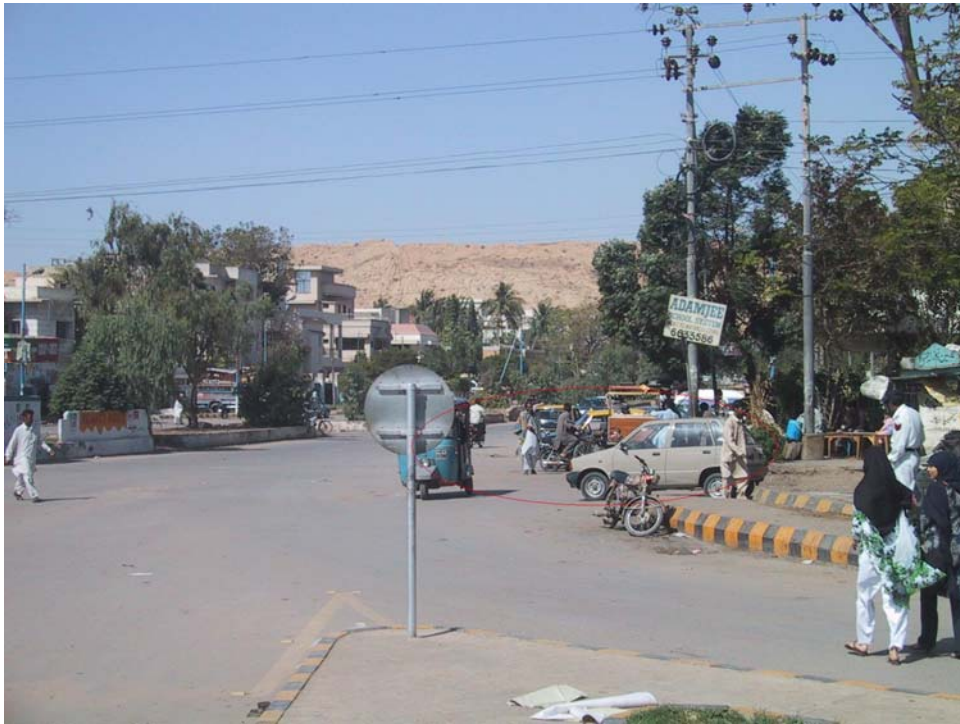
The service lane coming from Imam Hospital to the main road is a problem spot as the vehicles come onto the main road in speed and a chance of accident arises. Wrong way driving practice is also observed by the drivers of vehicles coming from Imam Clinic toward Shipowner's College.

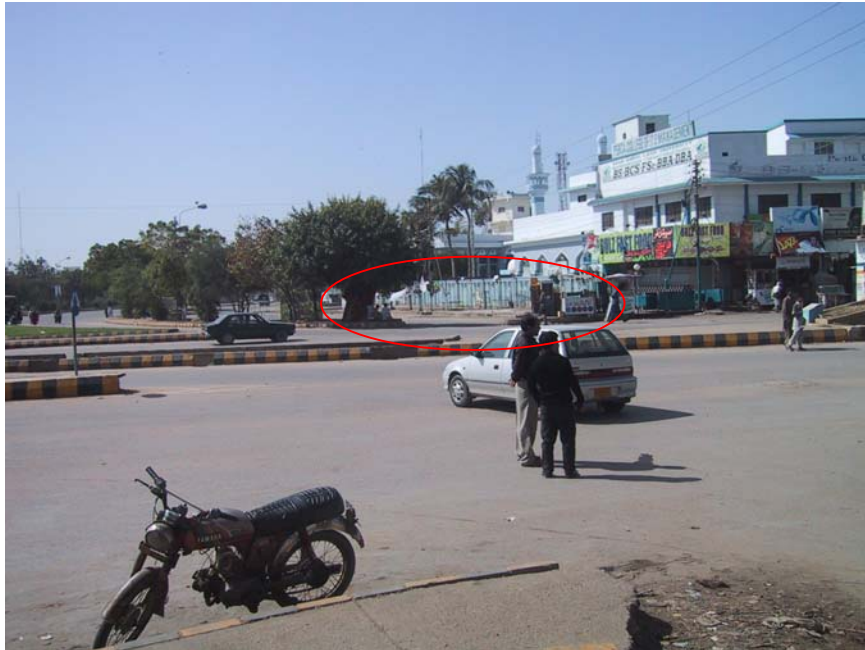
The service lane from Bab-ul-Ilm to the main road is problematic, as a left turn and the main road are merging at the entrance of the service road which creates a conflict among the vehicles going into the service lane and the ones left turning.

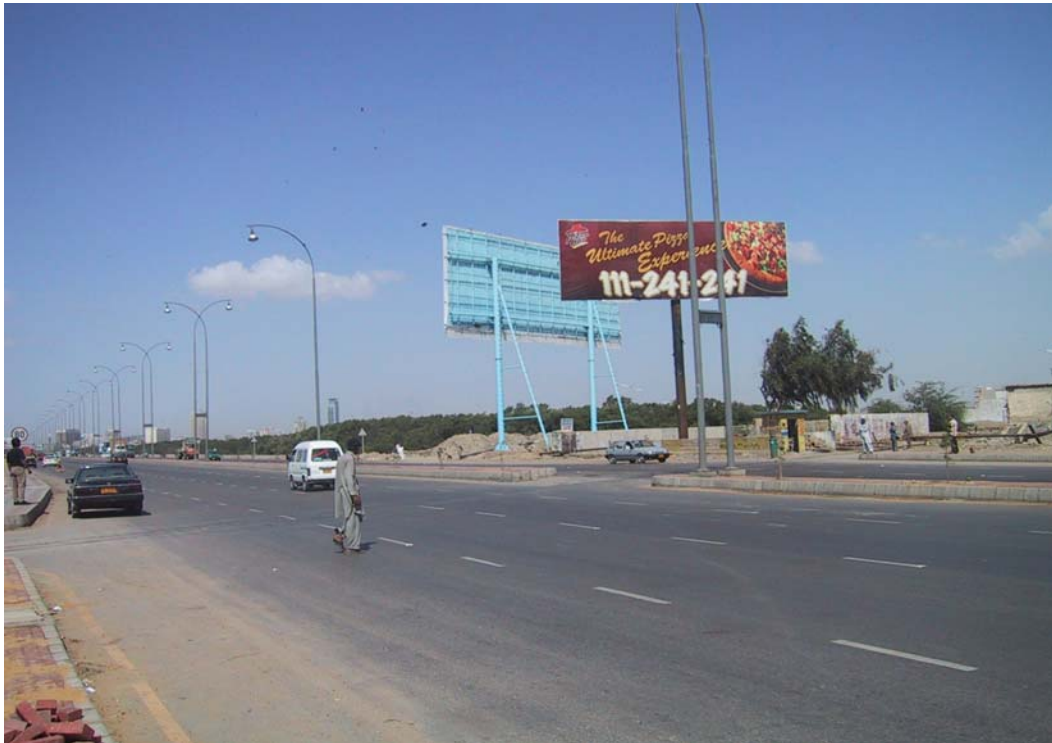
Pedestrians are facing problems crossing the road due to high speed of traffic especially during the morning and evening times.
