# **REPORT OF ROAD INJURY SURVEILLANCE PROJECT OF THE ROAD INJURY RESEARCH AND PREVENTION CENTRE OF JPMC, KARACHI**

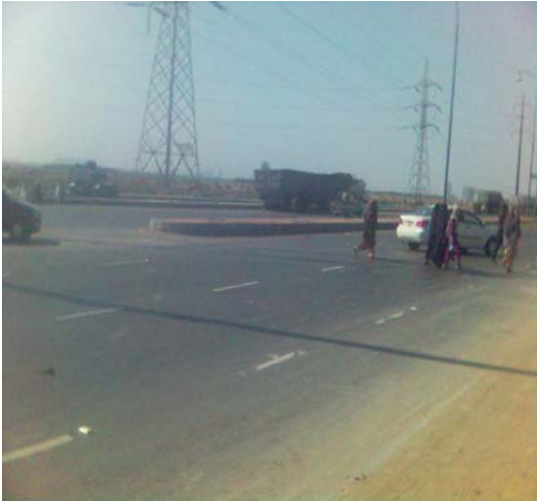
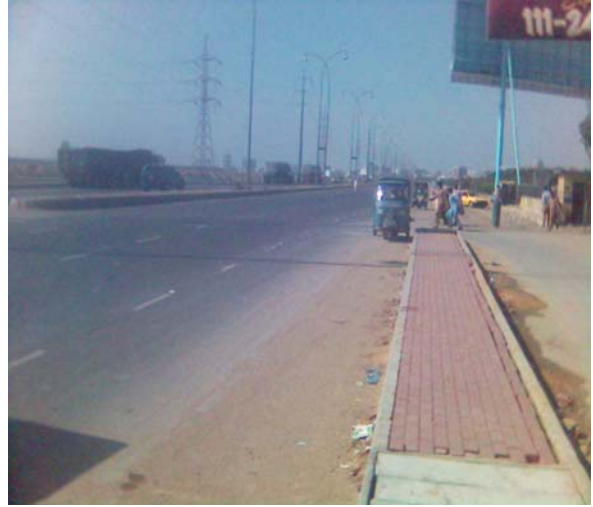
Wrong way driving practice is observed by the drivers of vehicles as they adopt wrong way from this U-turn to approach Hijrat Colony which is located at some distance this U-turn. Small portion of the traffic going from Boat Basin toward Tower is diverted from this U-turn and destination of some of these vehicles is Hijrat Colony for which they have to adopt a wrong way to approach Hijrat Colony. This wrong way driving practice is very dangerous as it is a very high speed road whose design speed is 80 km/hr and may result in a serious head-on collision.

1. It is recommended that a movable steel barrier be placed on the U-turn spot so that U-turn is not allowed and wrong way driving also stops. The U-turn cannot be closed permanently because of the railway line. The advantage of the steel barrier is that it can be moved by the railway chowkidar present at the spot whenever a train comes. There is another U-turn located near this spot. This will be utilized by the traffic for U-turning. It is safer as compared to the previous one.
2. A pedestrian bridge may be built adjacent to the railway line so that people can cross the road safely.
3. Bus stop may be allocated to the public transport near pedestrian bridge for safe loading and unloading of passengers as there is a huge pedestrian flow from Tikri and Hijrat Colony near this U-Turn.
